46TH TURBOMACHINERY & 33RD PUMP SYMPOSIA
HOUSTON, TEXAS | DECEMBER 11-14, 2017
GEORGE R. BROWN CONVENTION CENTER

Challenges with a large high pressure water injection pump

ABSTRACT

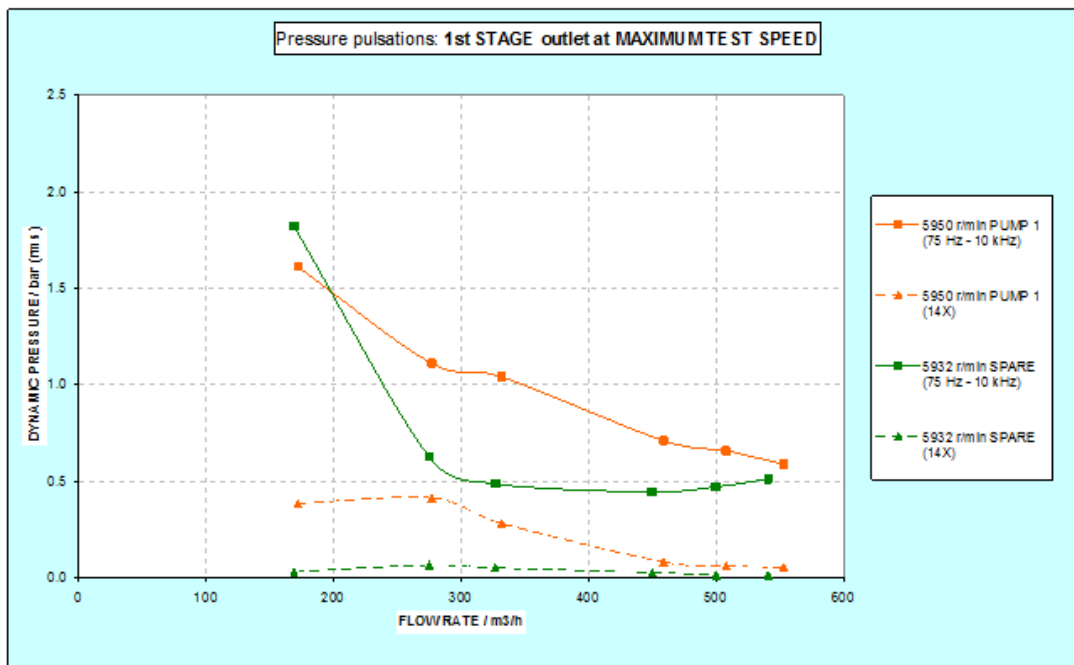
An additional spare cartridge was purchased with 285 mm impellers, instead of the original 288 mm (this increased the B-gap from 3.5 to 5.7%). Performance tests showed that this reduced the measured pulsation over most of the flow range, see Figure 11, but it also reduced the produced head by approximately 8% which is more than the affinity laws predicted $(285/288)^2=0.979$, see Figure 12. To meet injection demands the maximum speed of the power turbine was increased from 9060 to 9453 rpm, resulting in a pump speed of 5940 to 6200 RPM for the 285 mm pump cartridge only. This was possible because the original design limited the gas turbine's power turbine speed to 95 % of Max Continuous Operating Speed.

Figure 11. Comparison of 288 mm trim and 285 mm trim pulsation as % of line pressure (1st stage) 1 Bar = 14.5 psi

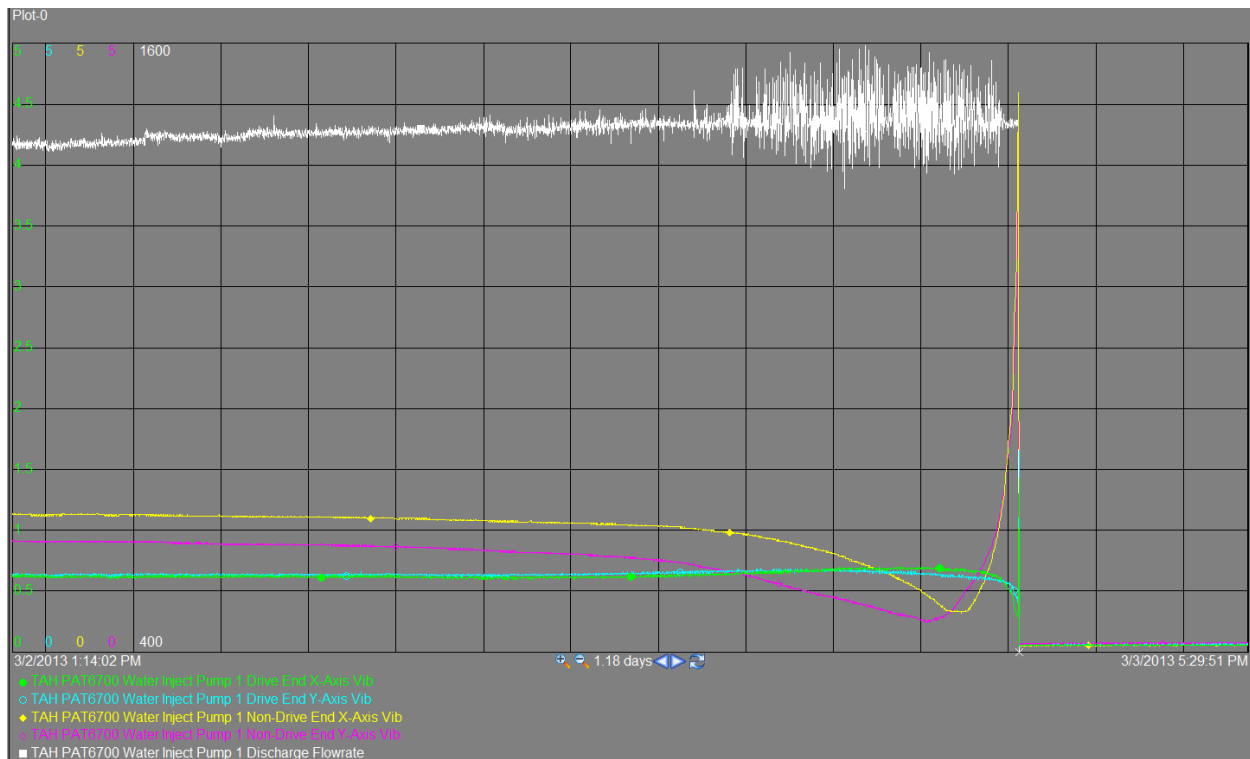
The two pumps with 288 mm impellers were commissioned in 2012 and ran with no problems until on March 28, 2013, when a high vibration trip occurred on the outboard end of the B pump. A rather unique characteristic of the vibration was that the outboard radial vibration began dropping prior to the rapid increase at the trip, which also coincided with an erratic flow reading, see Figure 13. The pump was restarted but the required injection pressure could not be reached due to the continued high vibration on the outboard end of the pump.

Figure 13. Trend of pump radial vibration (NDE-yellow, magenta), (DE radial-blue, green), flow - white

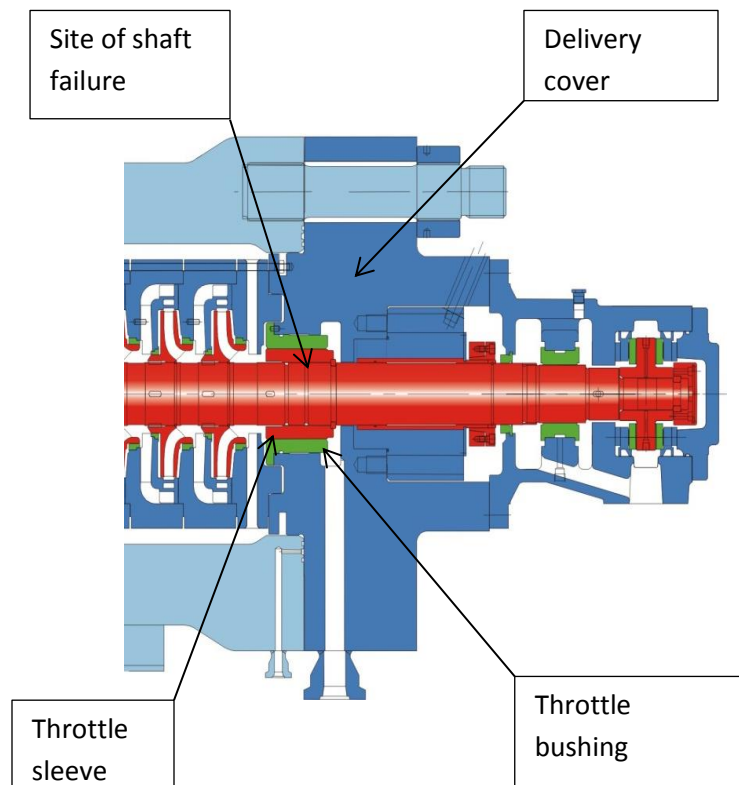
Teardown of the pump revealed that the shaft had failed completely underneath the throttle sleeve on the non-drive end at an O-ring groove in the shaft, see Figures 14 and 15. This was extremely unusual because the only power transmitted in that portion of the shaft is to drive the OB mechanical seal, OB sleeve bearing and thrust bearing (approximately 30 kW (40 hp)). Due to axial loads generated by the impellers and combination of torque loads, a back to back rotor experiences the highest loads at the center sleeve section (>100 times higher than at the failure location). As can be seen the failure is a torsional high cycle fatigue failure of the shaft that ended with ductile overload at the center (see Figures 16 and 17). Mechanical testing confirmed that the A276 super duplex shaft had poor fracture toughness at -40C and 70 C, see Tables 5 and 6. ASTM A276 does not specify acceptance criteria which are typically based upon specific purchaser requirements. A well heat treated super duplex forging should have good fracture toughness to low temperatures, and as such it is normal to conduct impact tests at -40°F (-40°C). Typical minimum acceptance criteria at this temperature are approximately 30 ft.lb (40J). Despite the low fracture toughness, the yield and ultimate stresses were still within ASTM

Figure 14. Cross-section of outboard (NDE) of water injection pump(Sulzer)

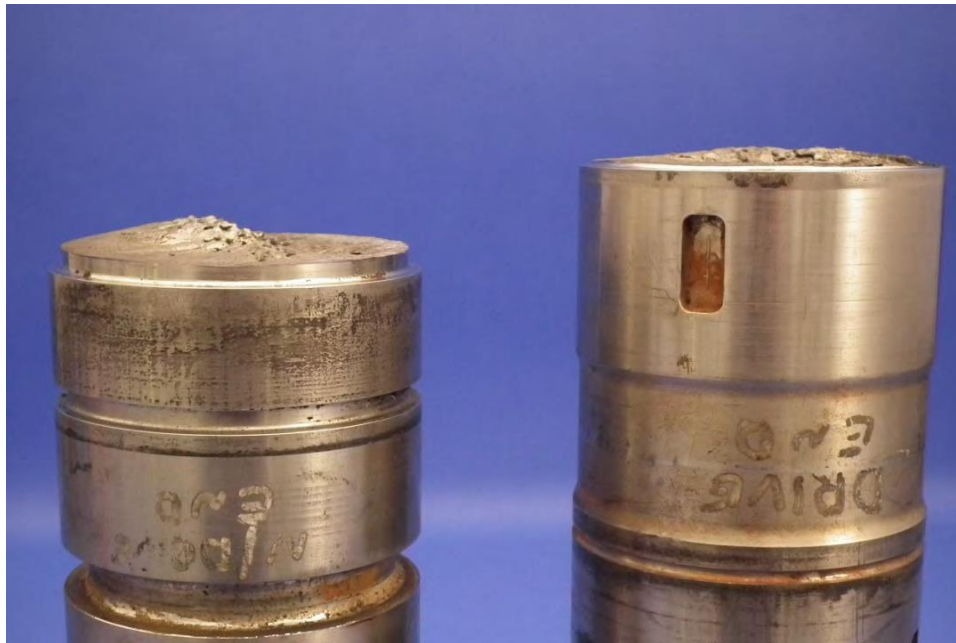
Although the O-ring groove had well profiled corners, the groove itself could still generate a localized stress concentration, which combined with the additional stiffness provided by the bushing makes this location more sensitive to cyclic loading. Due to the brittle nature of the shaft material at this location, minimal crack propagation would have been required before a sudden transgranular cleavage fracture caused complete shaft failure.

Figure 15. Failed shaft sections (NDE on Left hand side). Note O-ring groove at failure point

- Modify the throttle sleeve and shaft design so that the O-ring grooves are located in the sleeve only. This will eliminate the possibility of a stress riser in the groove initiating a crack in the shaft, see Figure 20.
- Modify the stress relieving procedure to improve the fracture toughness of the super duplex shaft forging.

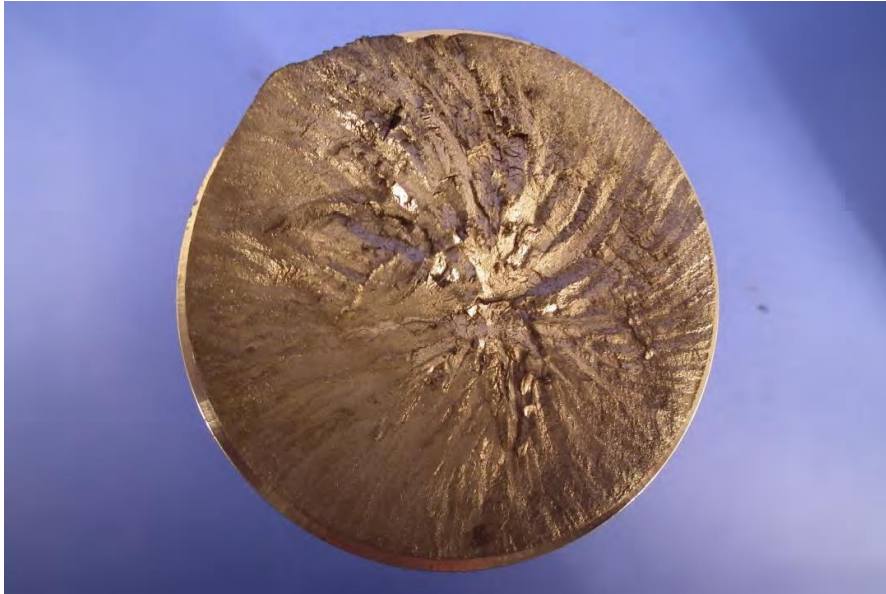
Figure 16. NDE (Non-Drive End) shaft fracture face

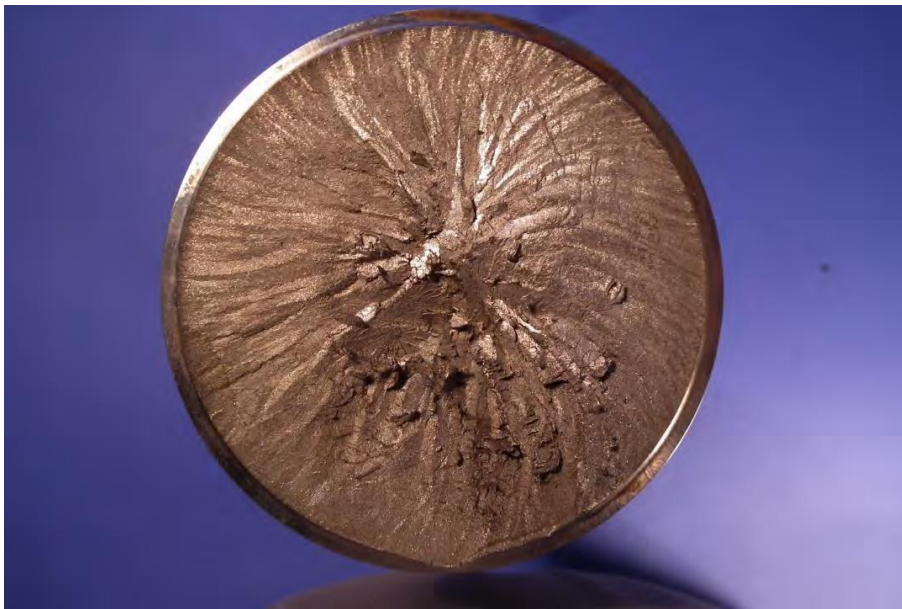
Figure 17. DE shaft fracture face

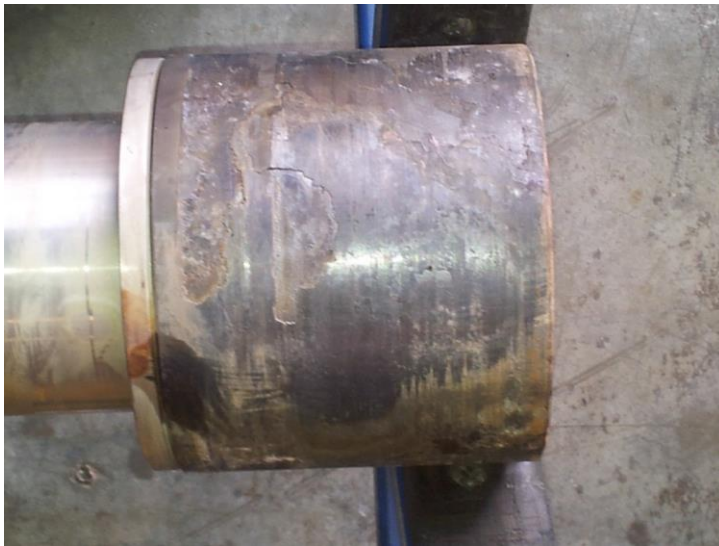
Additionally, examination of the throttle sleeve showed evidence of thermal distortion/wear, see Figures 18 and 19. However, it could not be confirmed if the damage to the sleeve occurred before or after the shaft failure, though it appeared somewhat old. The tungsten carbide coating has chipped away due to the excessive temperature. One possible cause was filter media contamination of the sleeve/bushing. Operations had had trouble with the suction filters on the pump plugging and then blowing through.

Figure 18. breakdown of tungsten carbide coating on throttle sleeve

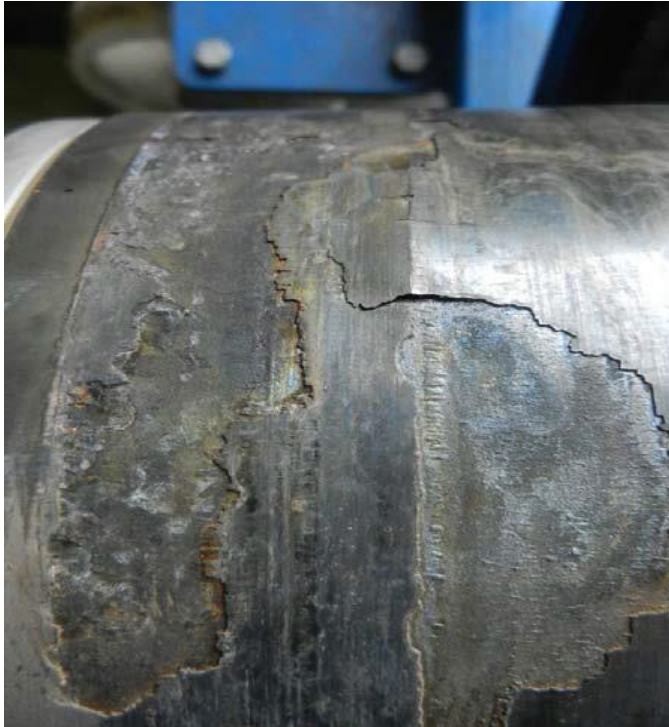
Figure 19. Close up of failed coating on throttle sleeve

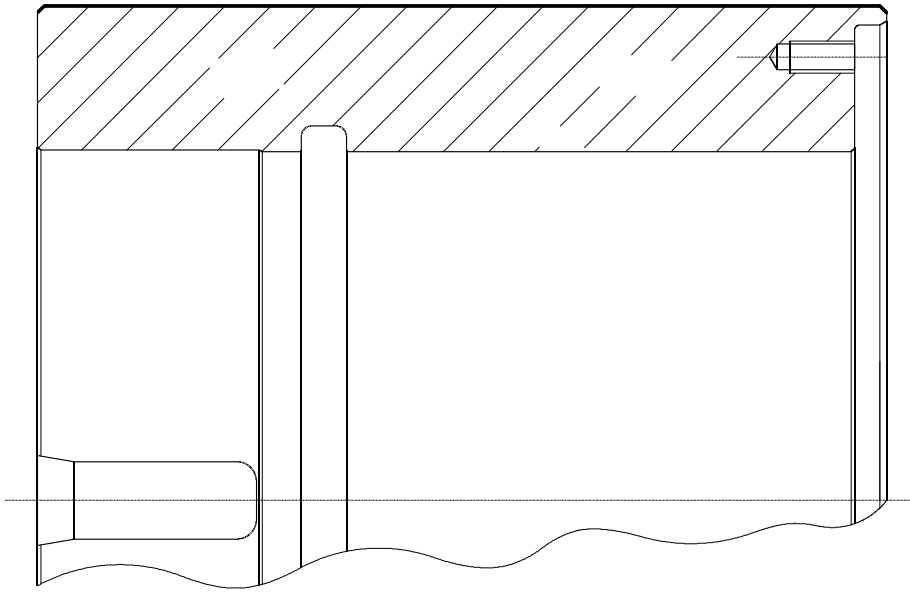
Figure 20. Sleeve modification with O-ring groove cut in sleeve only

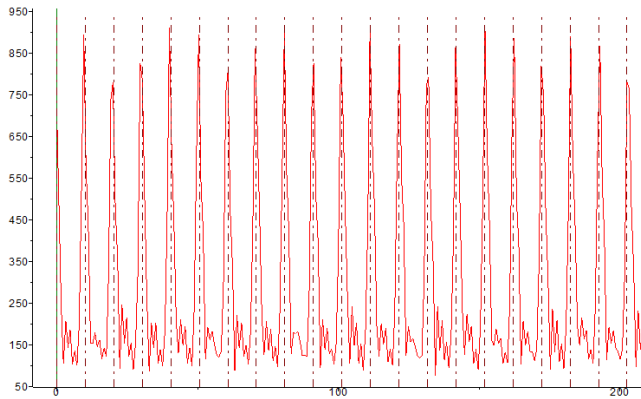
After the shaft failure, the spare cartridge with 285 mm impellers was installed in the B pump casing. The pump operated normally for several months until operations personnel noticed an unusual noise and vibration when the B pump was in operation. A predictive maintenance technician was called to investigate the noise and discovered a unique situation. The pressure pulsation in the equalizing chamber / balance line was very high: appx 41-48 bard (600-700 psid), see Figure 21. The bushing/sleeve in Figure 14, reduces the pressure on the outboard end of the pump from approximately 276 to 19 bar (4000 to 280 psig). Because the pressure pulsation seemed unreasonably high, the pulsation was recorded in the same location on the A pump, see Figure 22. This confirmed that the pressure recording was correct. Because of the previous issue with the broken shaft, it was decided to pull the B pump cartridge and tear down the pump.

Figure 21. Dynamic pressure pulsation (psi) recorded on B pump balance line during operation (appx 150 to 850 psi)

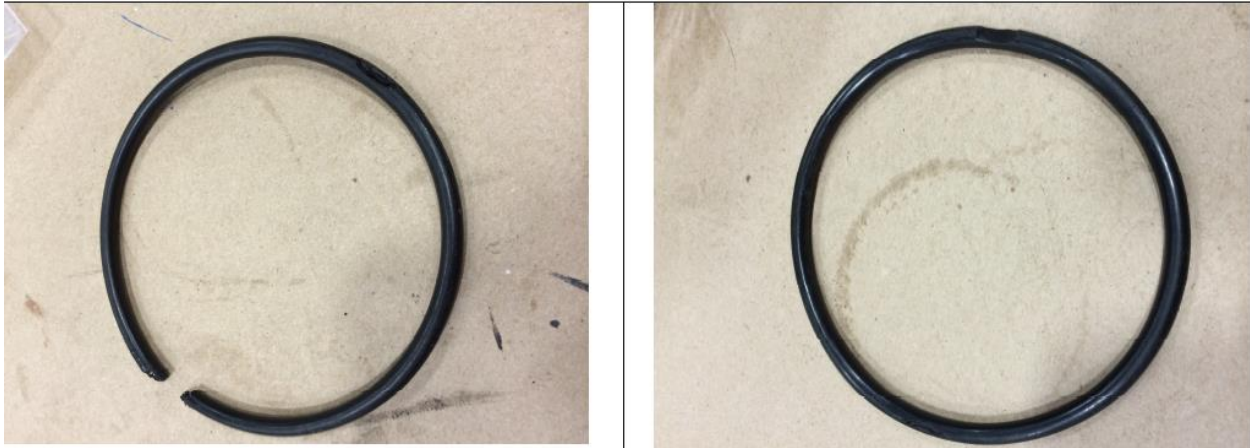
the pump found that the inboard O-ring (left hand side of Figure 23) under the sleeve had been cut, probably during installation, see Figure 24. The split rings and the axial groove in the shaft showed evidence of fretting, see Figures 25 and 26. This indicates that the rings were being loaded axially in a cyclic manner. The failure of the inboard O-ring allowed high pressure water to migrate a significant length under the sleeve. This may have caused the sleeve to “bow” or “flap” on the shaft, causing the pressure pulsation in the balance chamber. The pump OEM used an FEA model to simulate the effect of the failed O-ring on the sleeve, see Figure 27. As a solution, the throttle sleeve design was modified again to reduce the possibility of damaging the O-ring on installation by increasing the chamfer on the inlet side in alignment with newer designs of the same pump type which were introduced in the meantime. Installation of the spare cartridge in the B pump lowered the pulsation to approximately 7 bard (200 psid), see Figure 28, but still higher than the A pump which had only 3.2 bard (50 psid). Both pumps have operated for the past 3 years with no more reliability issues. The pulsation on the balance chamber is still routinely recorded and has not increased.

Figure 24. Inboard(LHS) and outboard(RHS) O-rings from throttle sleeve

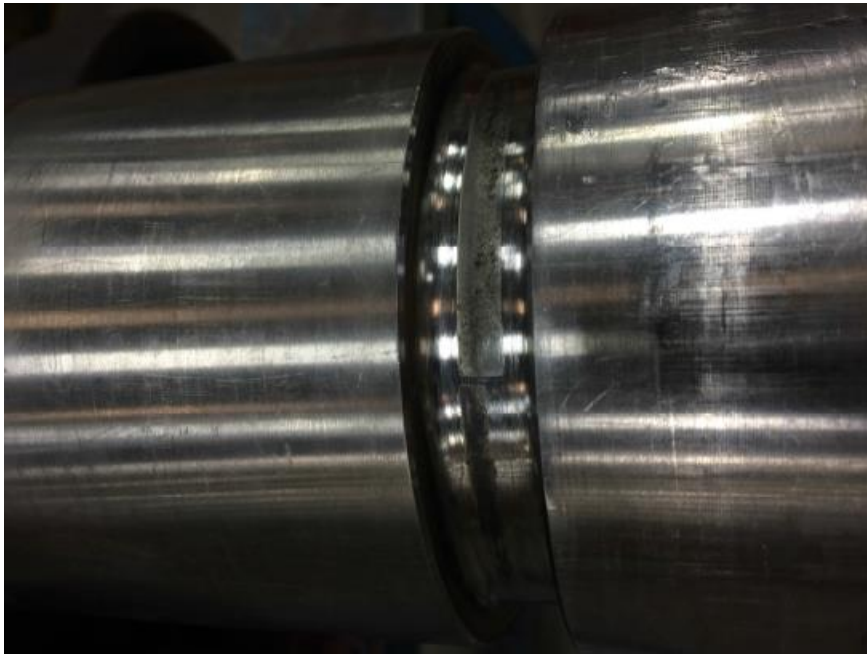
Figure 25. Shaft groove for split rings showing fretting from vibration

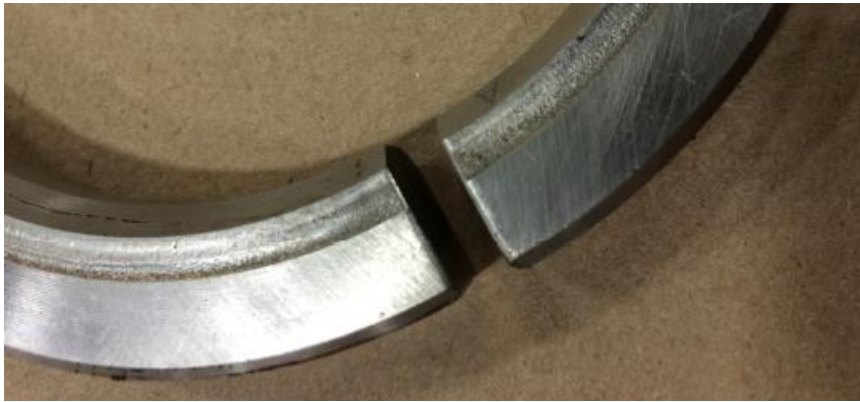
Figure 26. Fretting on split rings, evidence of vibration

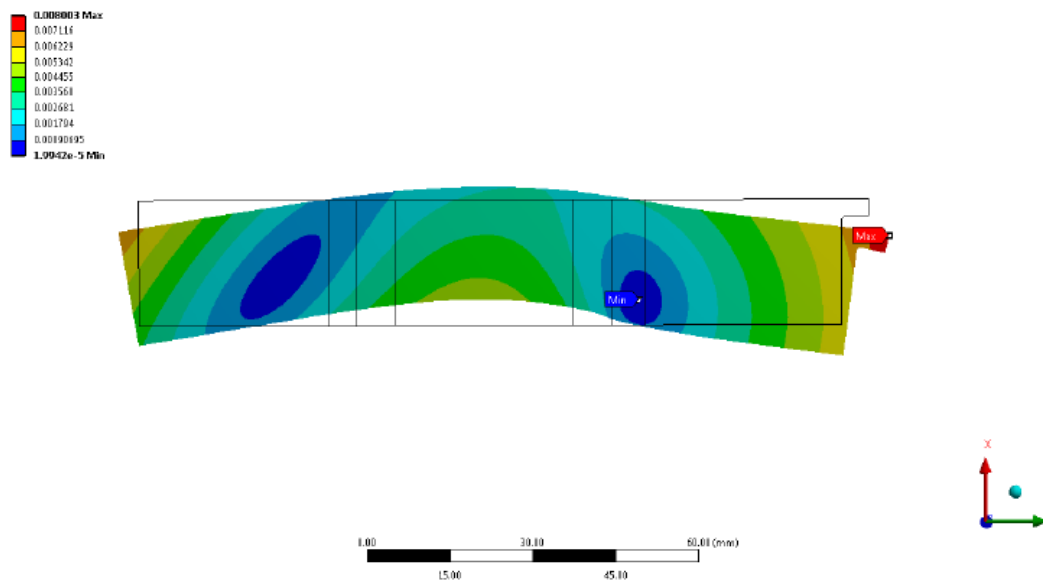
Figure 27. FEA model of sleeve with failed inboard O-ring, showing exaggerated deformation(Sulzer)
